## Optimized Tube Plugging for Air Cooled Heat Exchangers

**Pop-A-Plug®**

*Tube Plugging System*

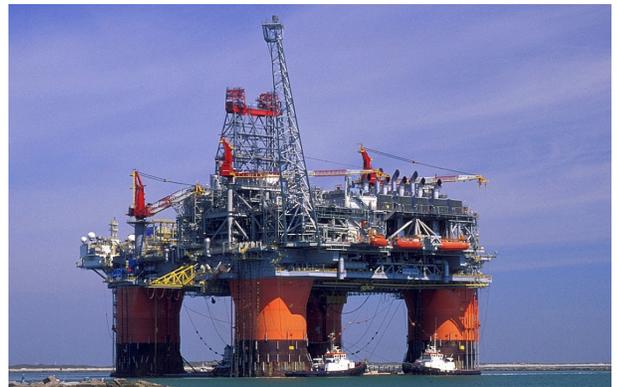
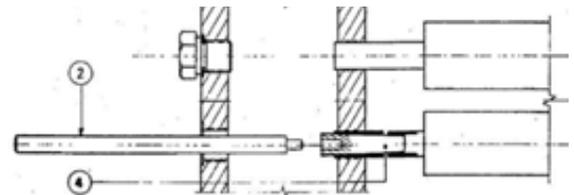
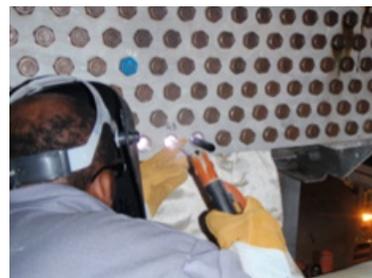
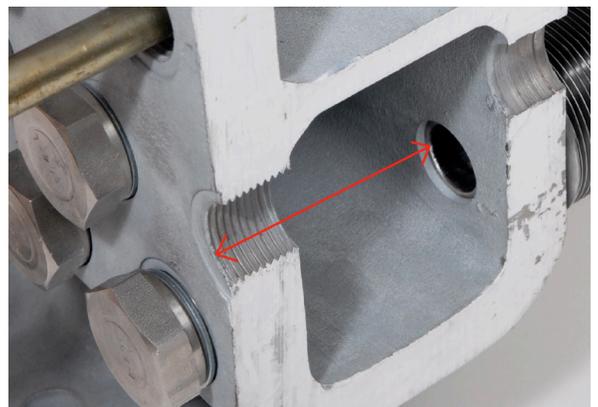
The main repair challenge with ACHE units is at the tubesheet where the tube requiring plugging is recessed (4" - 24") deeper than the point where the service plugs are located (red arrow). This requires the use of modified tools to access this “remote” plugging point “at depth”.

Tools were developed that solve the issue of installation of the plugs at depth, including G-150 Test Guns, Tube Preparation brush kits, Go/NoGo Gauges, Pop-A-Plug® Ram, Channel Pull Rod Assembly, and Pop-A-Plug® Heat Exchanger Tube Plugs. EST Group ensured all the steps taken during the Pop-A-Plug® installation process could be executed with simple tool extensions allowing each step to be done “at depth”.

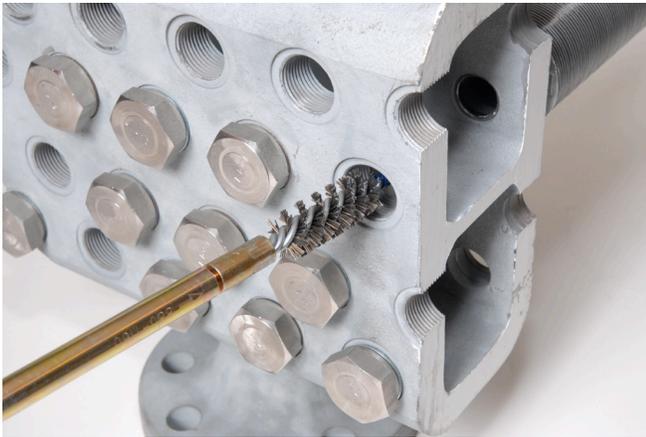
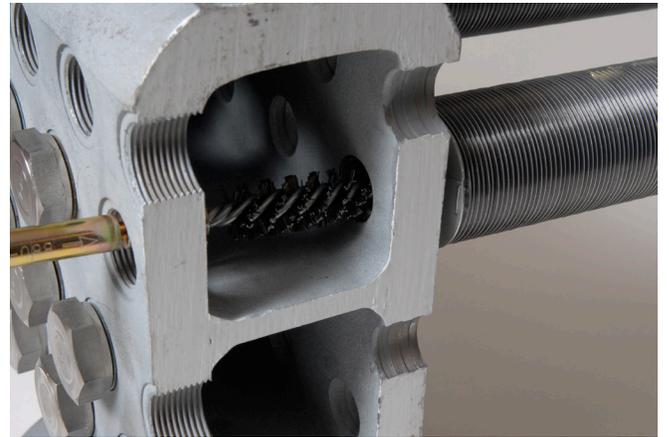
Tube Brushing (Cleaning inside of tube of scale, rust, debris etc. for a clean surface)

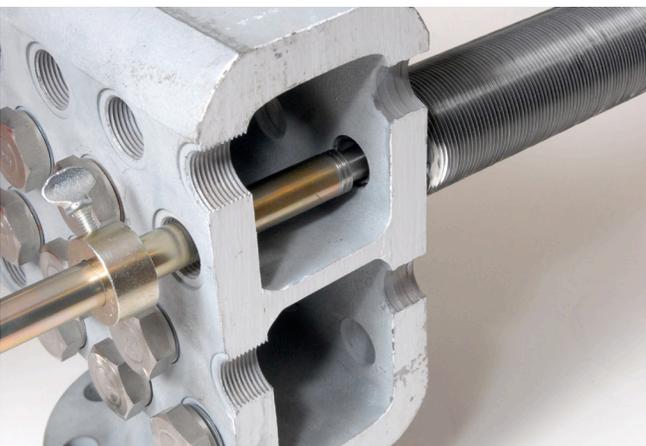
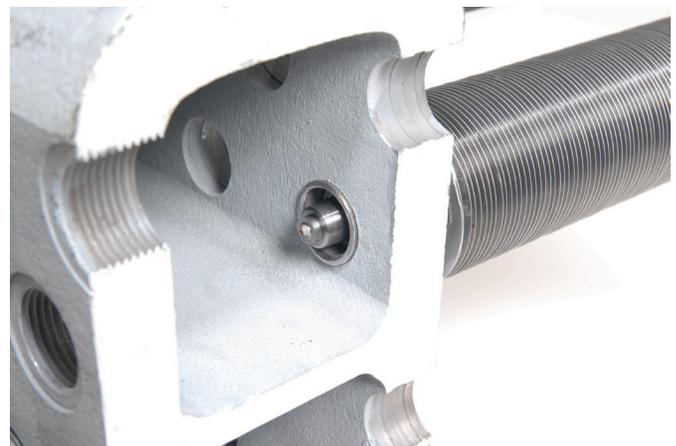
Plug Installation (Installing Pop-A-Plug® inside the tube sheet at depth)

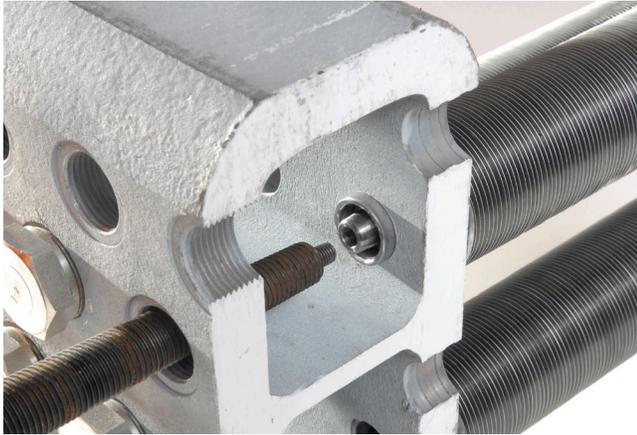
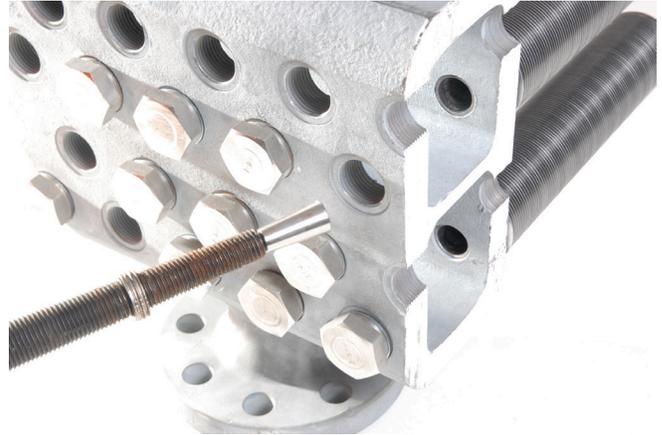
Removal (Easy removal of the installed Pop-A-Plug® in preparation for re-tubing)
